# Manhole Inspection Summary

Manhole # S33I\_\_006MH

Insp Date: **3/26/08 7:39 AM**

**Location** Address: **200 w. pratt**

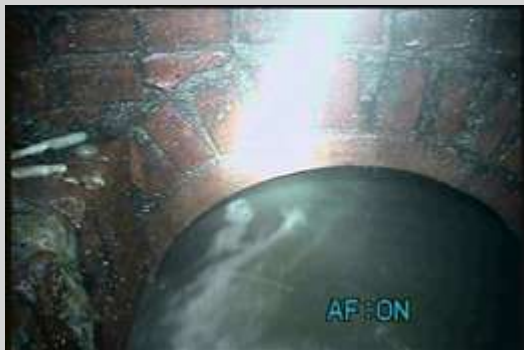
12 O'Clock Outflow

21 in. Circular Gravity Sewer  
Pipe Out @ 12 O'Clock

Invert Depth: **27.20** (ft.) Flow Characteristics: **Turbulent**

Deposits: ☒ None ☐ Mud ☐ Sludge ☐ Debris ☐ Grease

Infiltration: **None** Pipe Seal Cond: **Unknown**

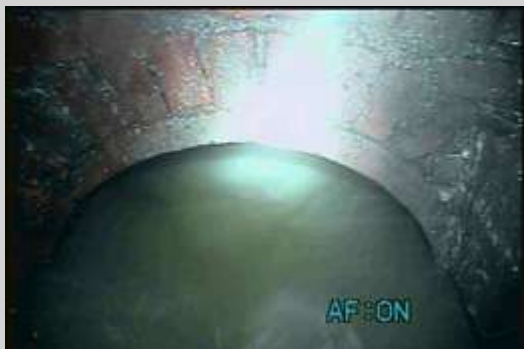
6 O'Clock Inflow

21 in. Circular Gravity Sewer  
Pipe In @ 6 O'Clock

Infiltration: **None** Pipe Seal Cond: **Unknown**
